## **Appendix 1**

### **Photograph Log**

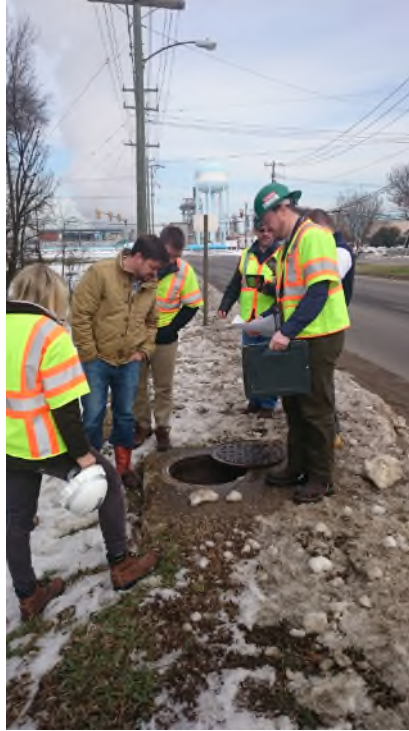
**Photograph 1. Outfall 5-57: Randolph Road and Winston Churchill Drive.**

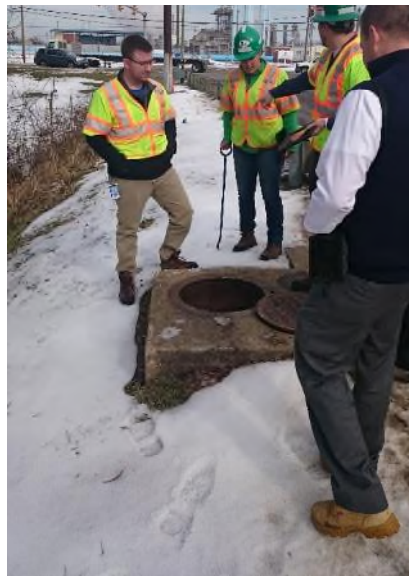
**Photograph 2. Outfall 5-57: Randolph Road and Winston Churchill Drive.**

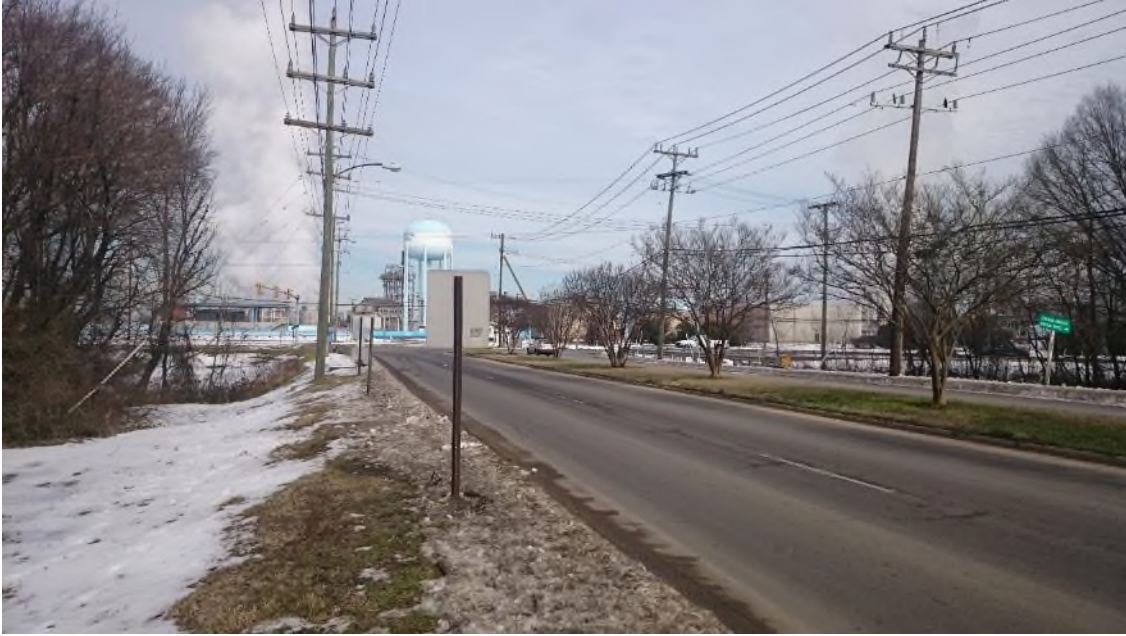
**Photograph 5. Outfall 5-57: E. Randolph Road and Winston Churchill Drive, the manhole where monitoring occurs is on the lefthand side of the road.**

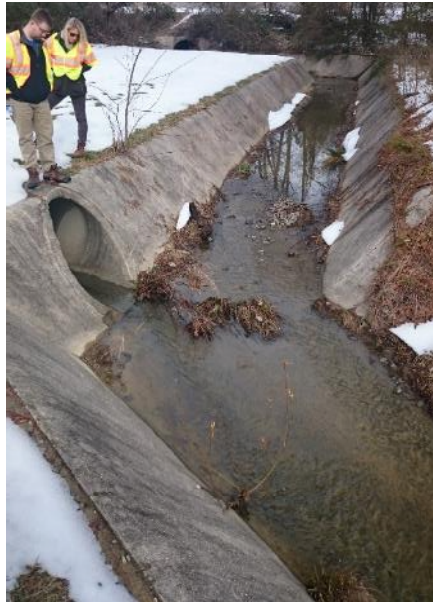
**Photograph 6. Outfall 6-27: Cattail Creek looking upstream.**

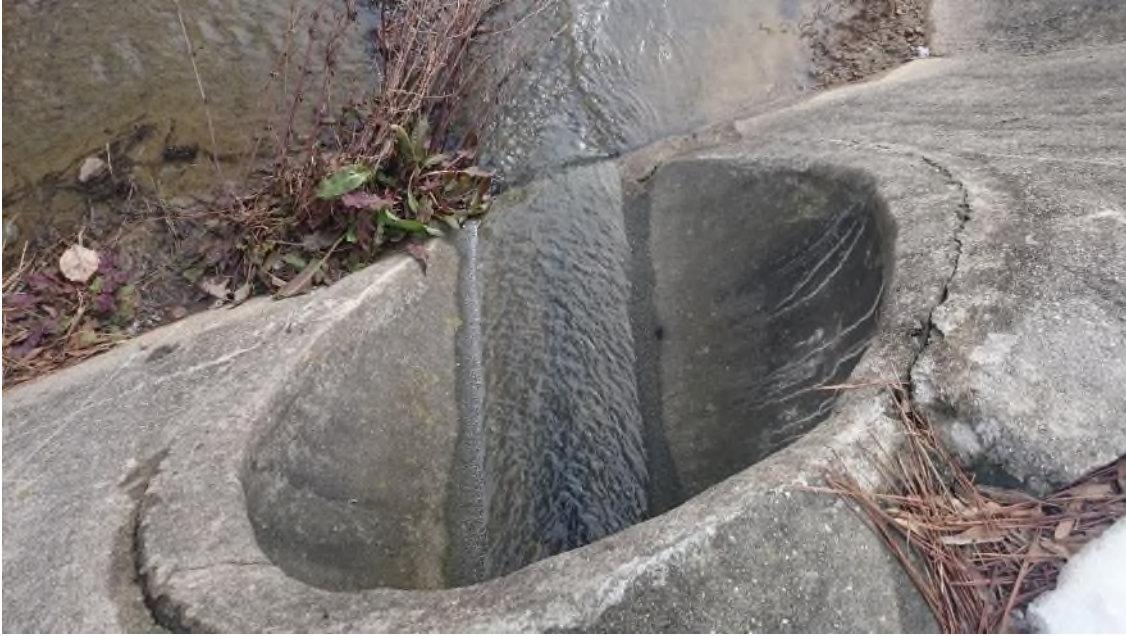
**Photograph 7. Outfall 6-27: Discharge into Cattail Creek.**

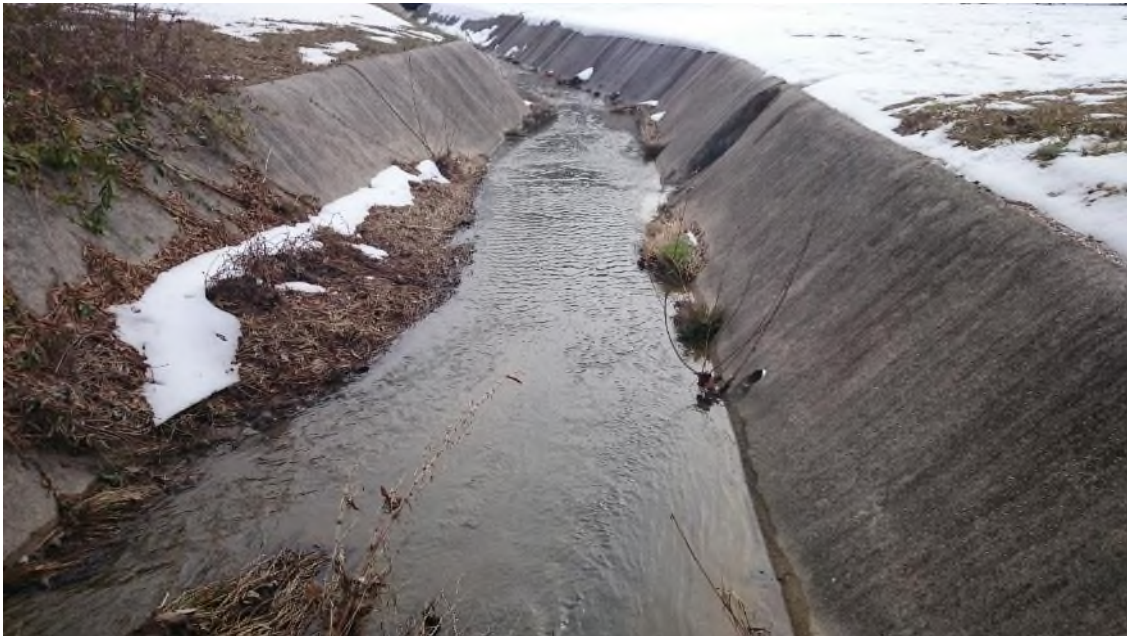
**Photograph 8. Outfall 6-27: Looking downstream of Cattail Creek.**

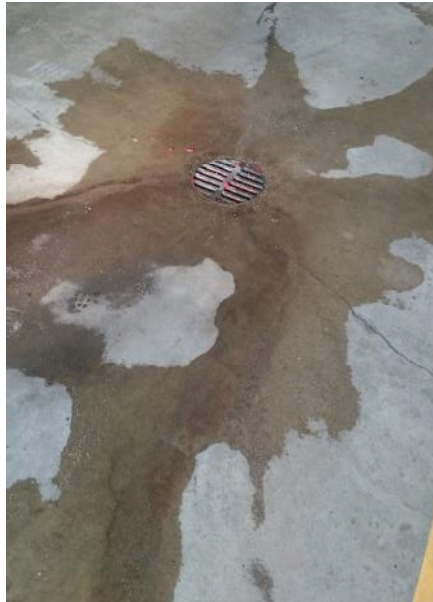
**Photograph 9. Public Works Facility: Sewer drain in fire department bay (Building A – Facility Map).**

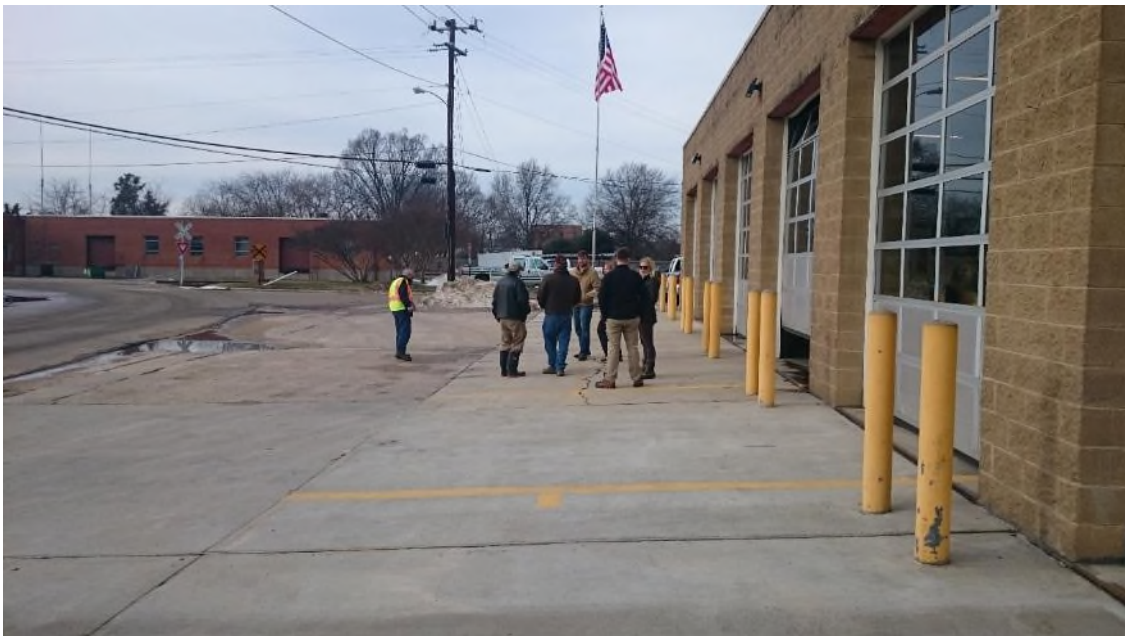
**Photograph 10. Public Works Facility: Front pad of fire department (Building A – Facility Map).**

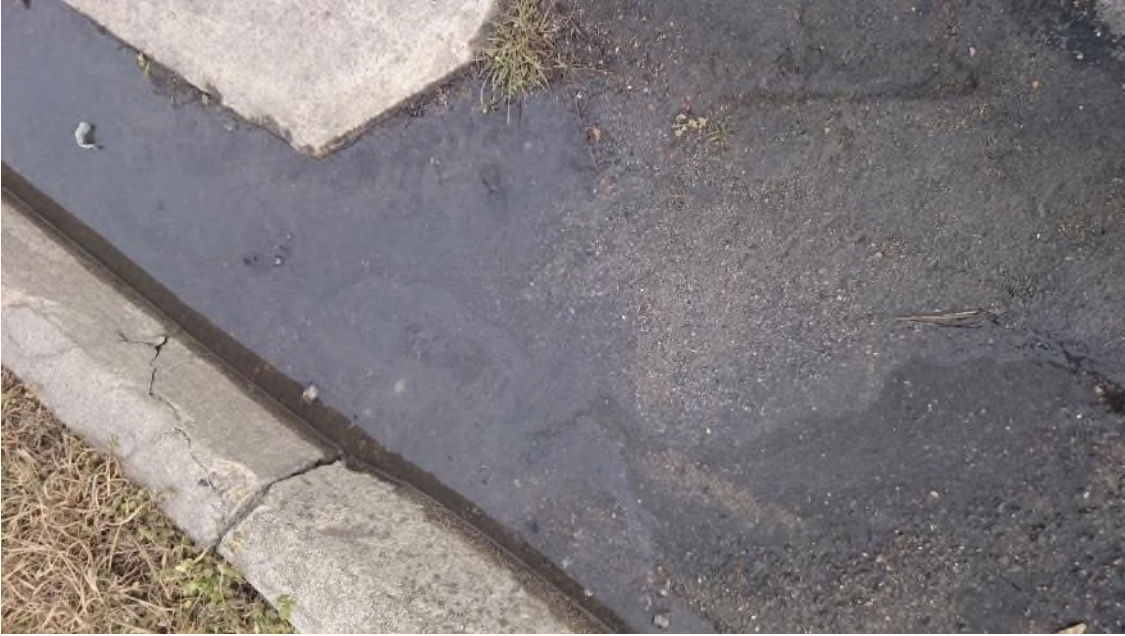
**Photograph 11. Public Works Facility: Standing water next to fueling island (Building C – Facility Map) located adjacent to a railroad track.**

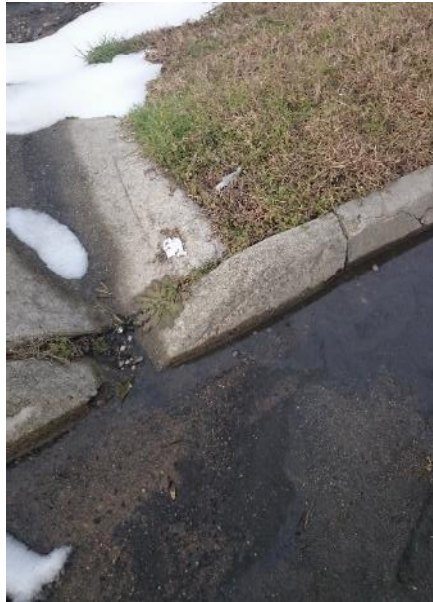
**Photograph 12. Public Works Facility: Alternate view of Photograph 11 with drainage to railroad track (background).**

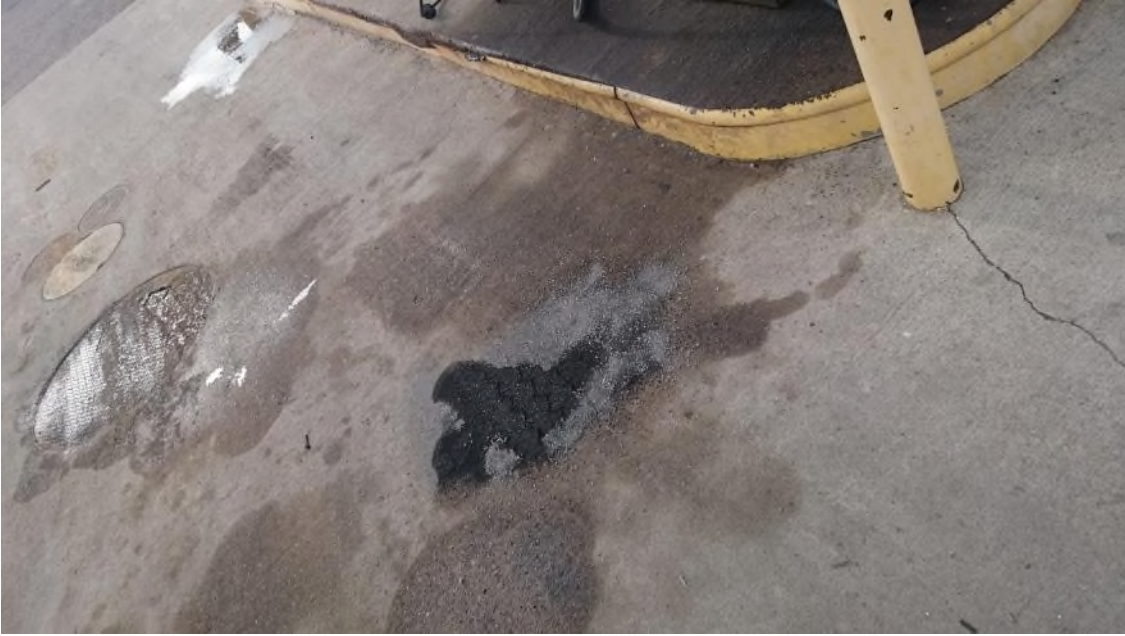
**Photograph 13. Public Works Facility: Visible oil on fueling island pad (Building C – Facility Map).**

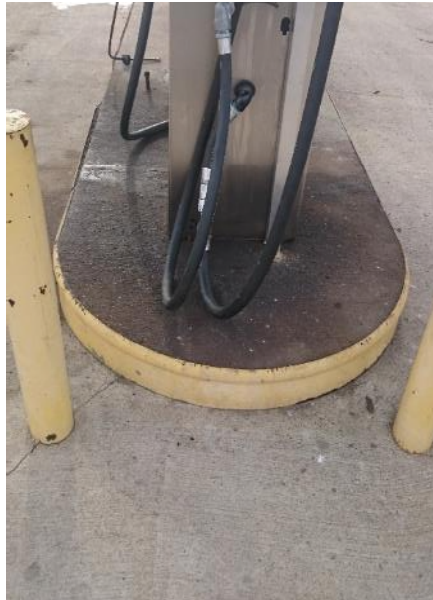
**Photograph 14. Public Works Facility: Additional area of oil on ground surface near rear of fueling island (Building C – Facility Map).**

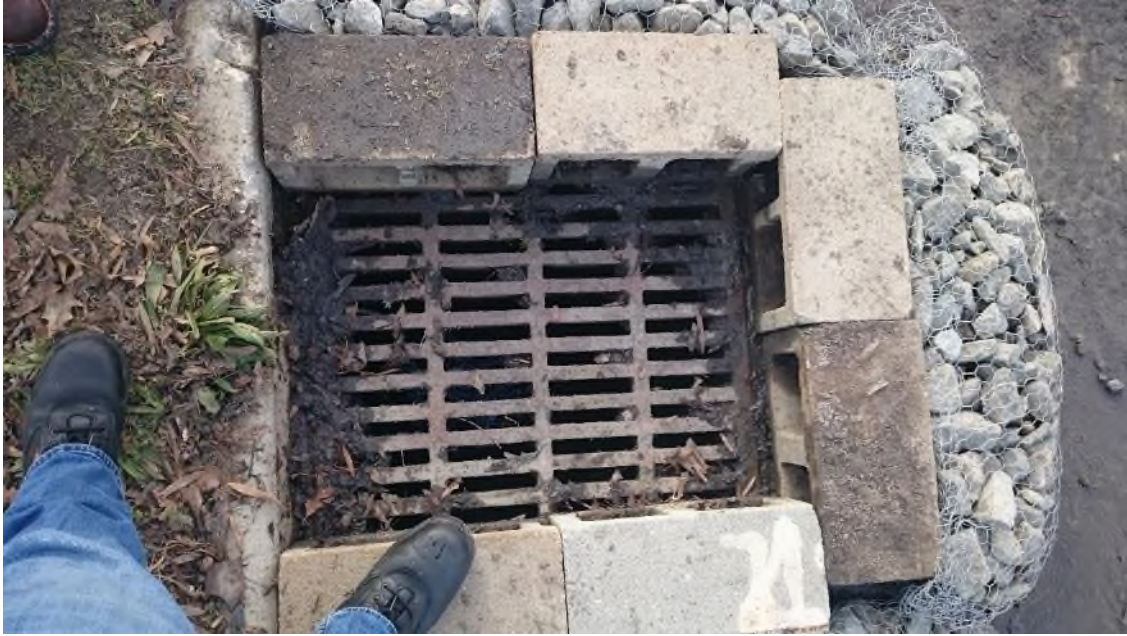
**Photograph 17. Public Works Facility: Alternate view of catch basin inlet protection in Photograph 16.**

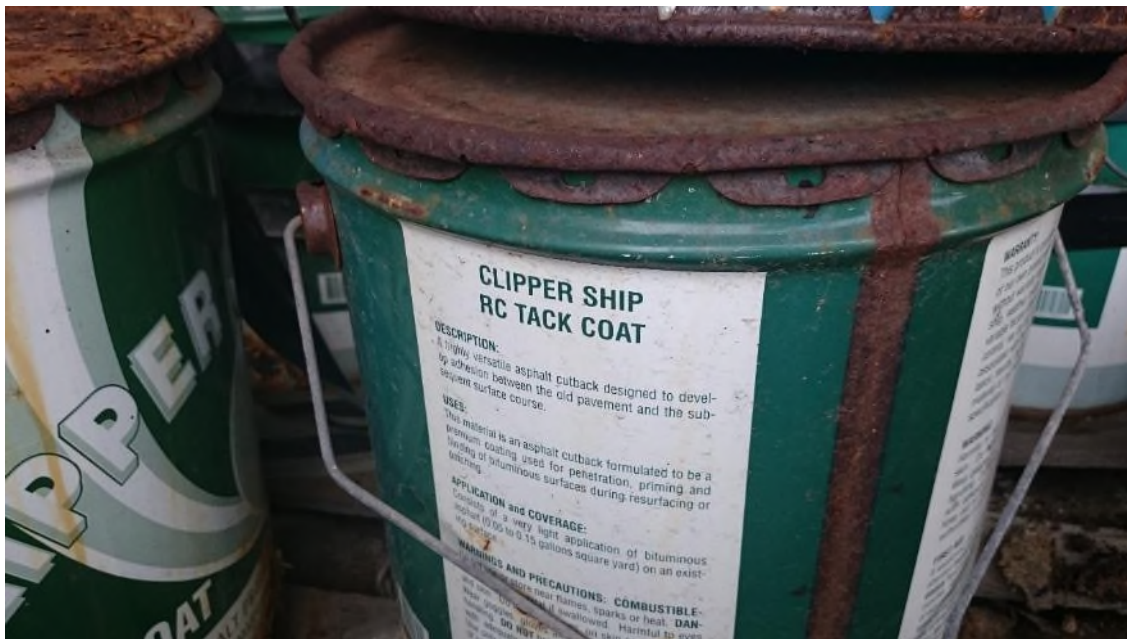
**Photograph 20. Public Works Facility: Alternate view of label on the containers stored in the Equipment and Materials Storage Building depicted in Photograph 18.**

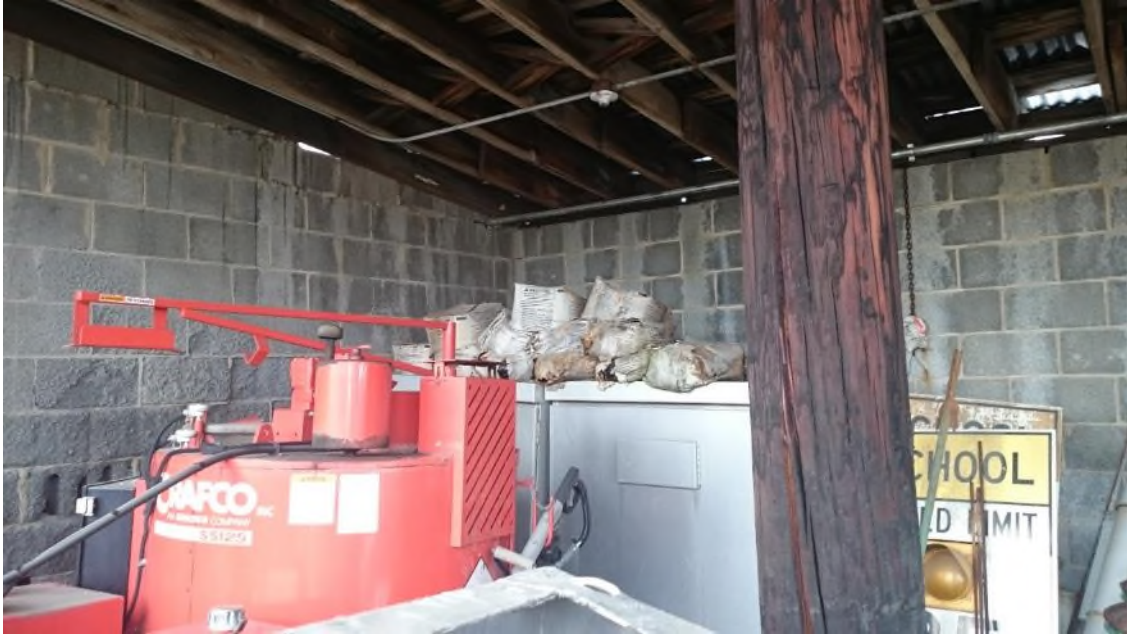
**Photograph 21. Public Works Facility: Storage bags inside the Equipment and Material Storage Building (Building F - Facility Map).**

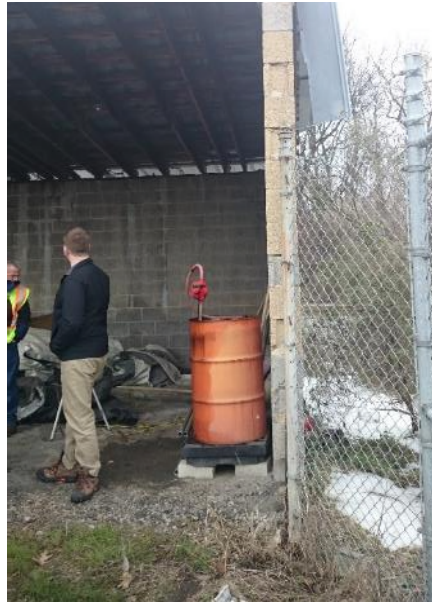
**Photograph 22. Public Works Facility: Metal drum containing petroleum product used on concrete form work inside the far north side of the Equipment and Materials Storage Building (Building F - Facility Map).**

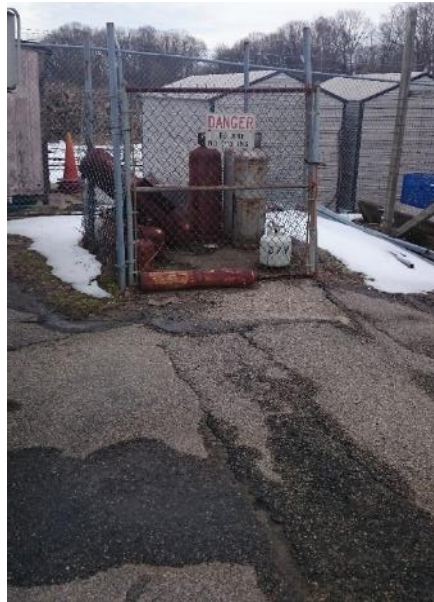
**Photograph 26. Public Works Facility: Propane tanks located south of Vehicle Storage Area 12 and Equipment Storage Area 13 (Facility Map).**

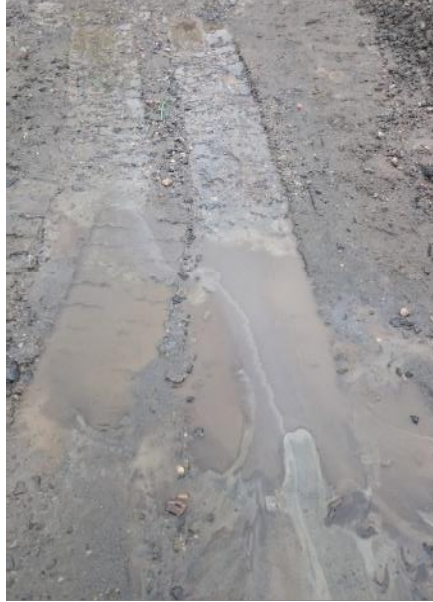
**Photograph 27. Public Works Facility: Oil sheen on water flowing towards low point located near Outdoor Storage Area 10 and Vehicle Washing Area 11 (Facility Map), where the drain was clogged.**

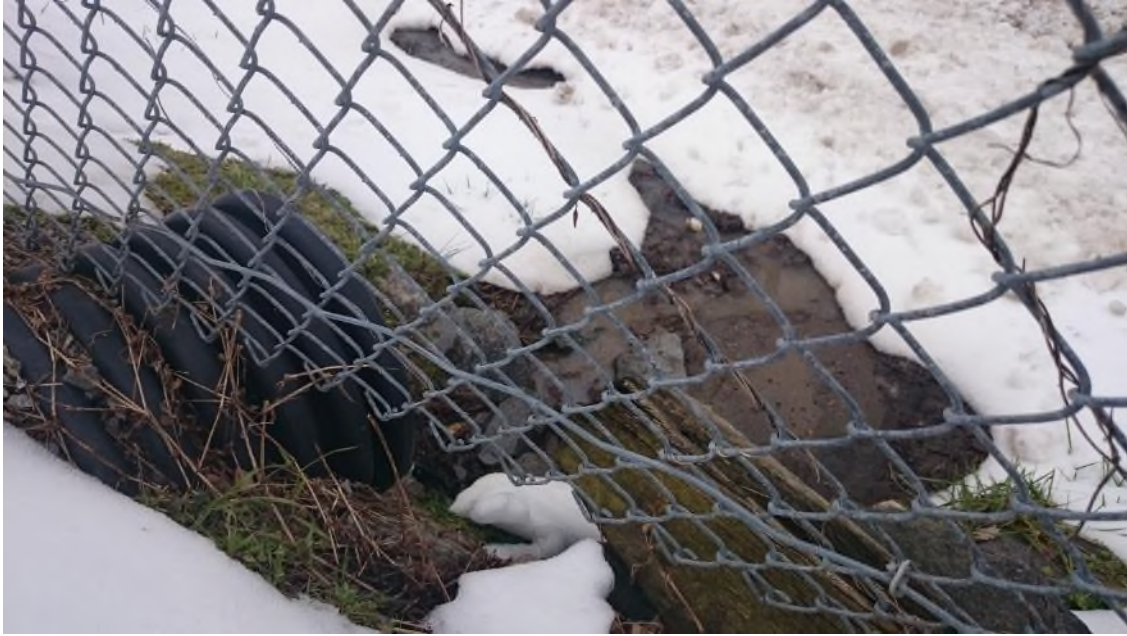
**Photograph 29. Public Works Facility: Pipe draining out of the Vehicle Washing Area 11 (Facility Map) to Station Street.**

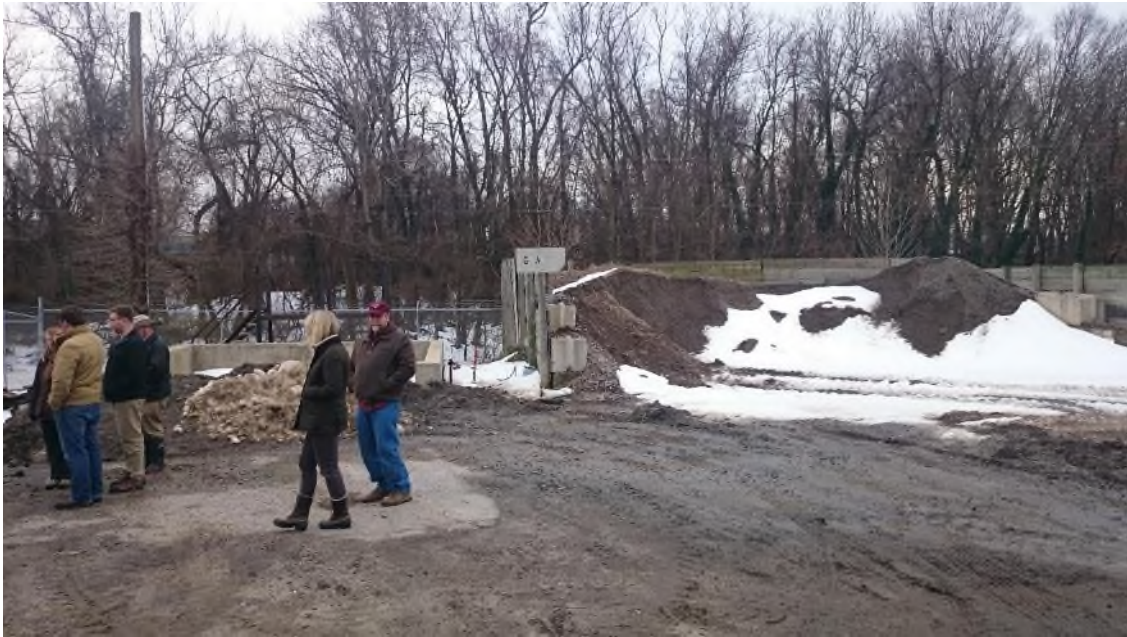
**Photograph 30. Public Works Facility: Open gravel pit located in low point near Outdoor Storage Area 10 and Vehicle Washing Area 11 (Facility Map).**

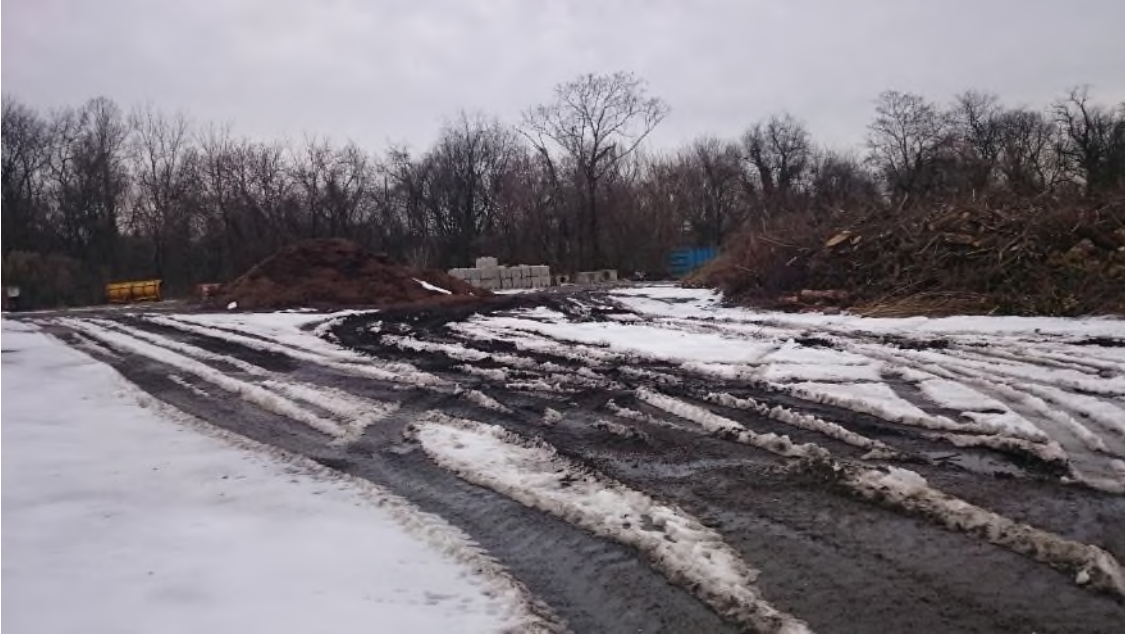
**Photograph 31. Public Works Facility: Outdoor Storage Material Area 15 (Facility Map).**

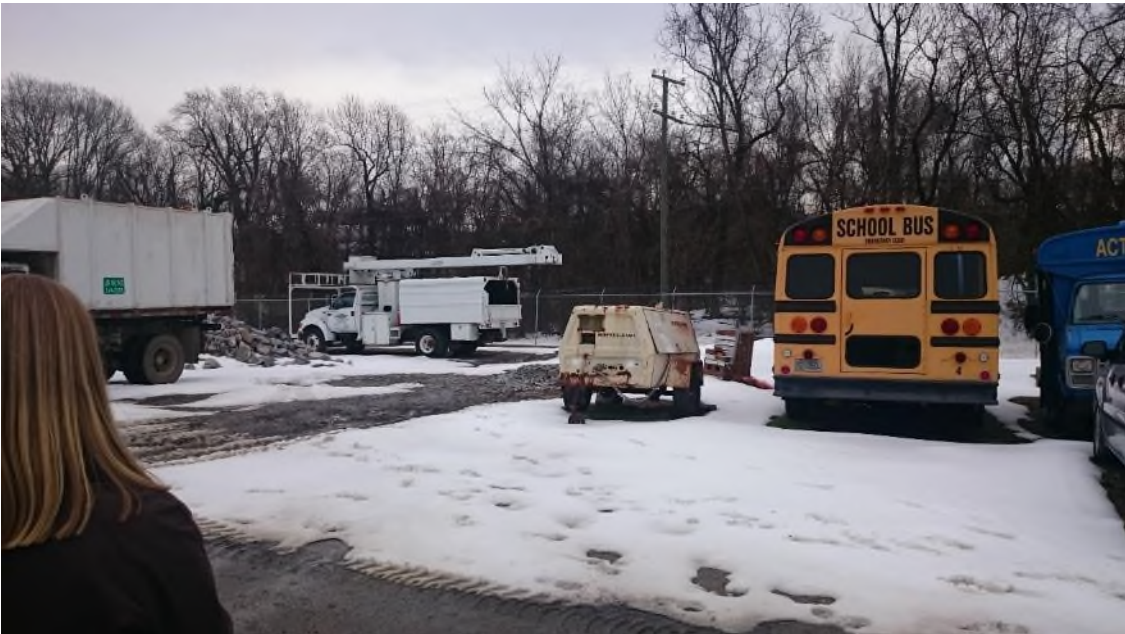
**Photograph 32. Public Works Facility: Vehicle/Equipment Storage Area 15 (Facility Map).**

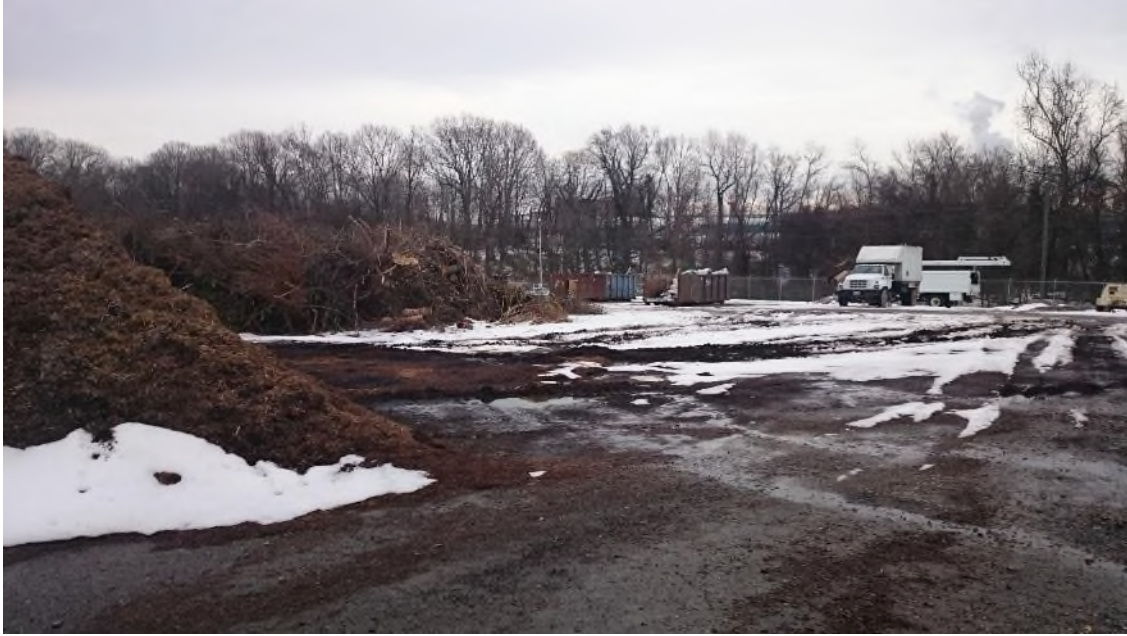
**Photograph 33. Public Works Facility: Looking downhill from Equipment Storage Area 13 towards Storage Area 16 (Facility Map).**

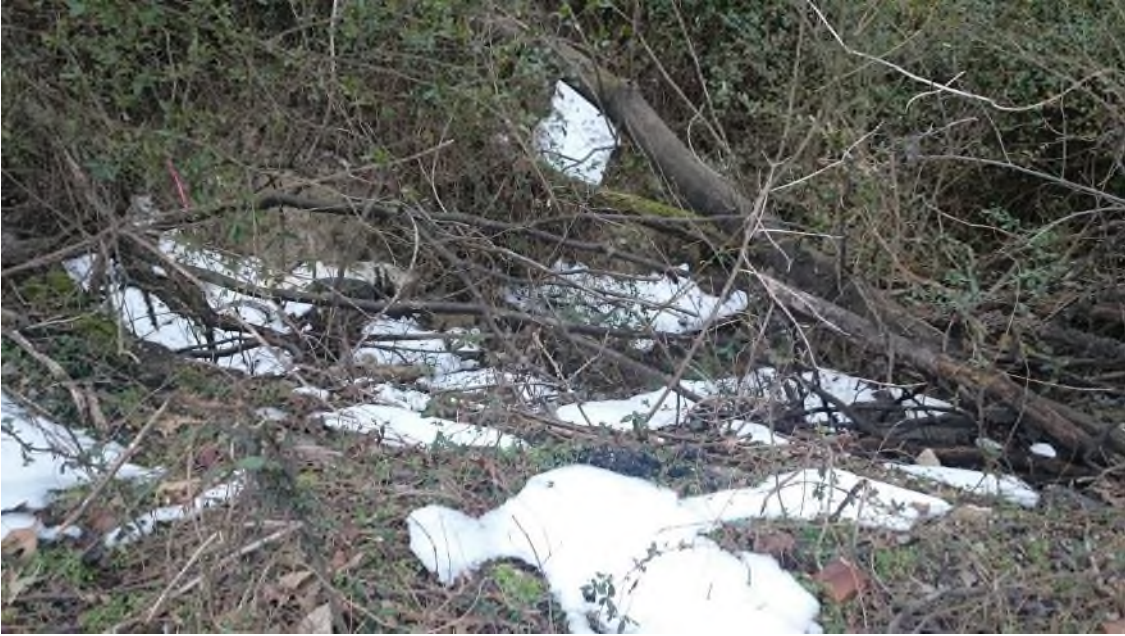
**Photograph 37. Public Works Facility: Creek with flowing water approximately 10 feet northwest and downhill from the street sweeping pile pictured in Photograph 36.**

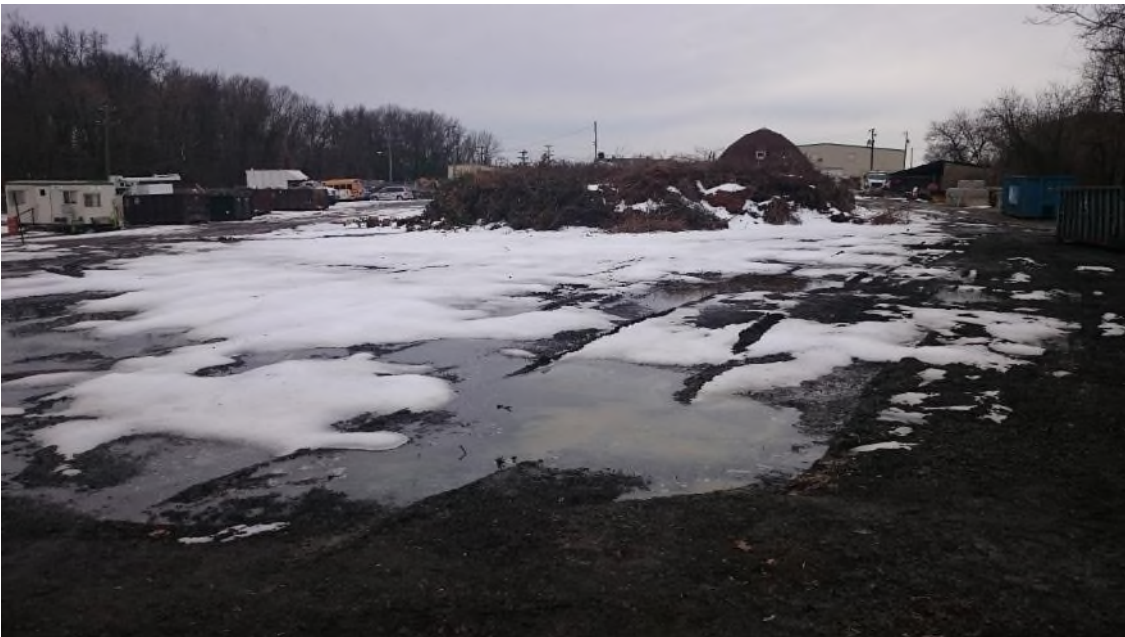
**Photograph 38. Public Works Facility: From the north end of the Outdoor Material Storage Area 15 (Facility Map) looking southwest.**

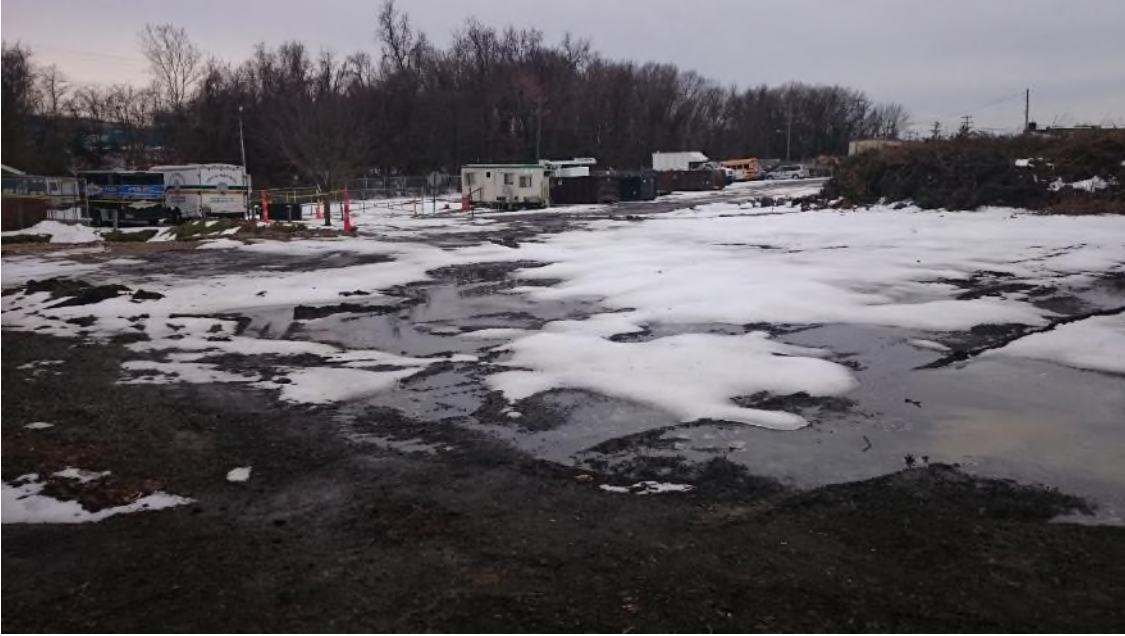
**Photograph 39. Public Works Facility: Alternate view of Photograph 38, looking southwest of Outdoor Material Storage Area 15 (Facility Map).**

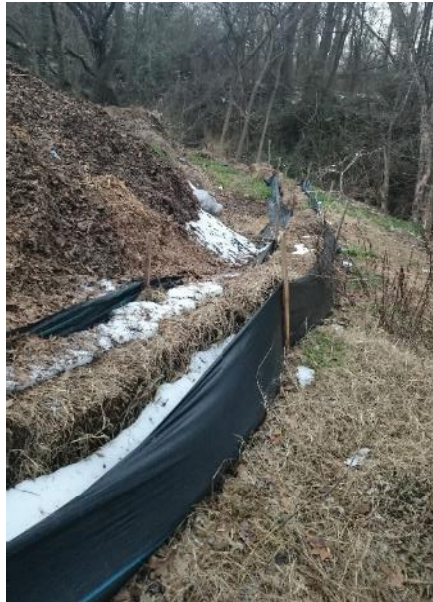
**Photograph 40. Public Works Facility: Silt fence located behind sweeping pile pictured in Photograph 36.**

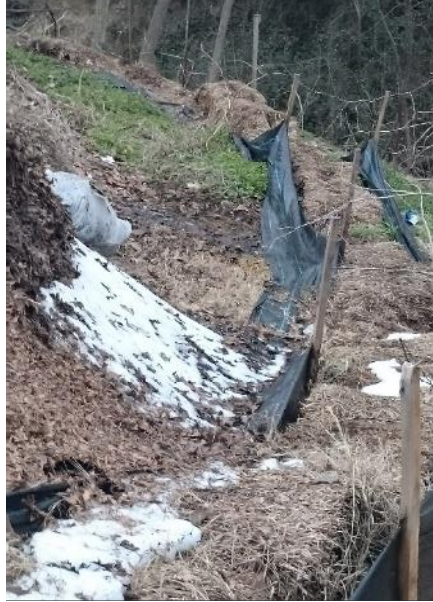
**Photograph 41. Public Works Facility: Silt fence behind street sweeping pile pictured in Photograph 36.**

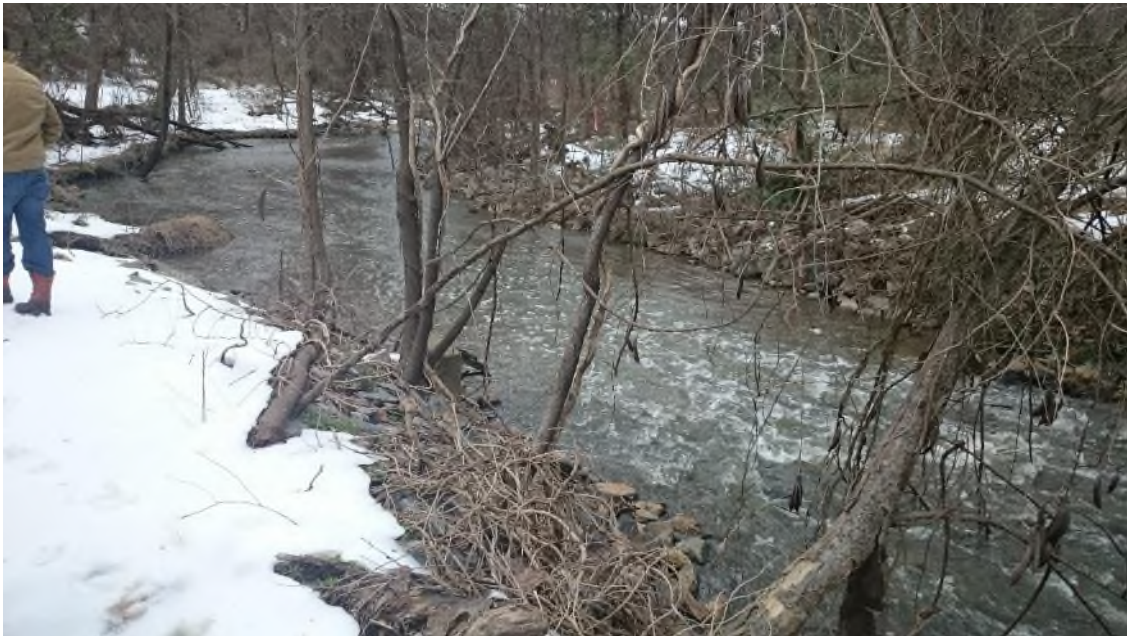
**Photograph 42. Public Works Facility: Poythress Run, down gradient of the street sweeping pile pictured in Photograph 36.**

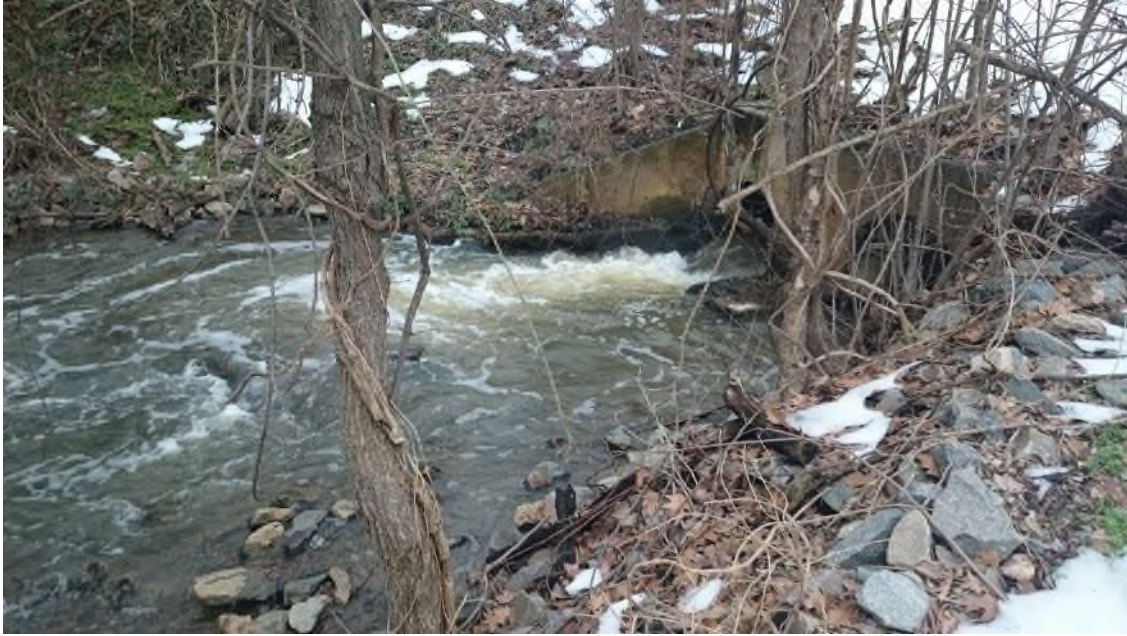
**Photograph 43. Public Works Facility: Alternate view of Poythress Run, down gradient of the street sweeping pile pictured in Photograph 36.**

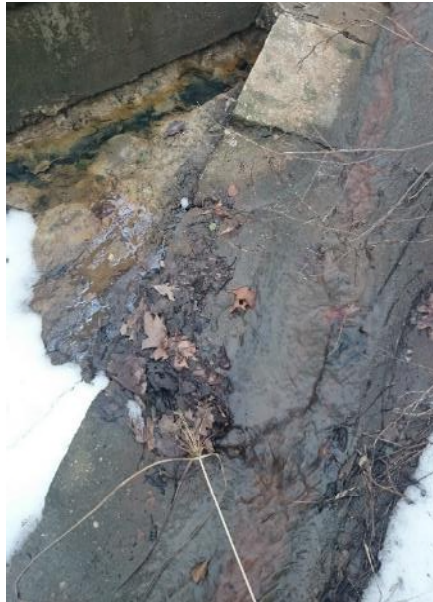
**Photograph 44. Public Works Facility: Outfall 2 (Facility Map) and Outfall 5-59 in the City's Outfall Inventory.**

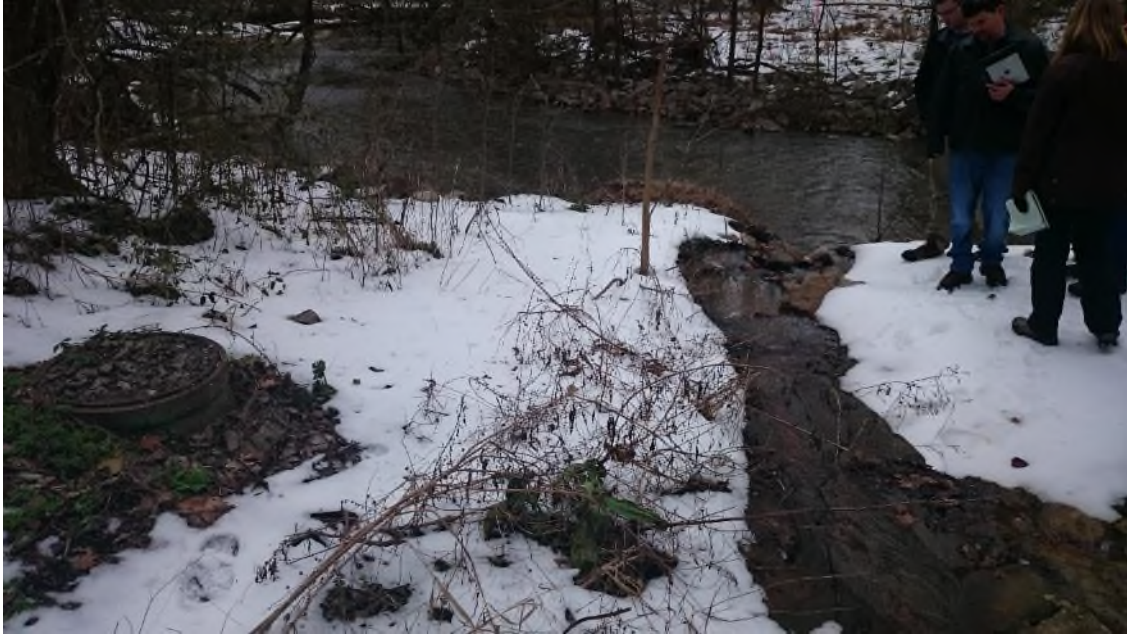
**Photograph 45. Public Works Facility: Outfall 2 (Facility Map) to the right and sanitary sewer to the left, with Poythress Run in the background.**

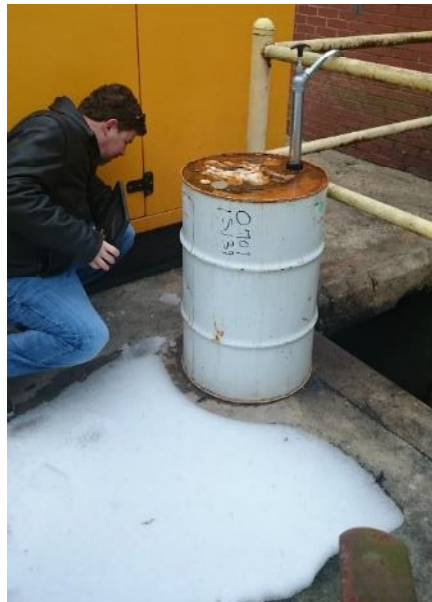
**Photograph 46. Public Works Facility: Drum in Pump Station (Building J – Facility Map).**

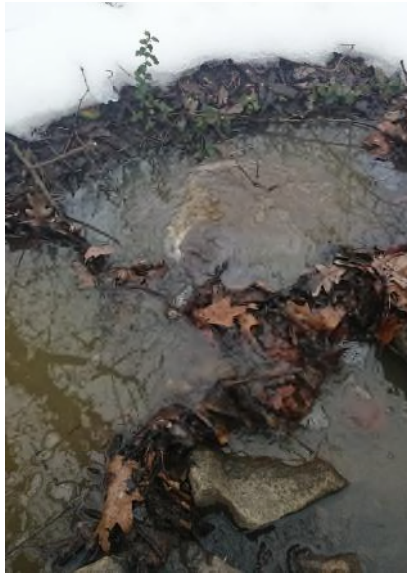
**Photograph 47. Public Works Facility: Outfall 2 (Facility Map).**

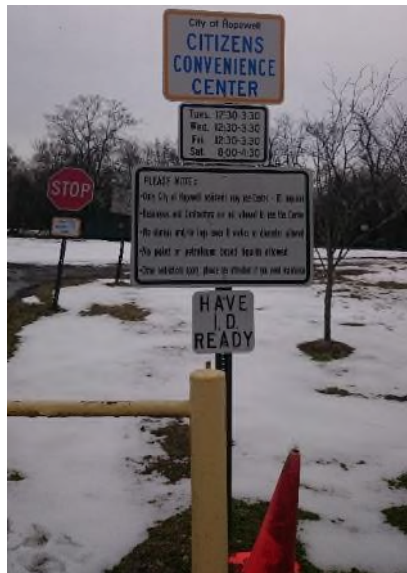
**Photograph 48. Public Works Facility: Sign located at the public entrance to the Citizens Convenience Center.**

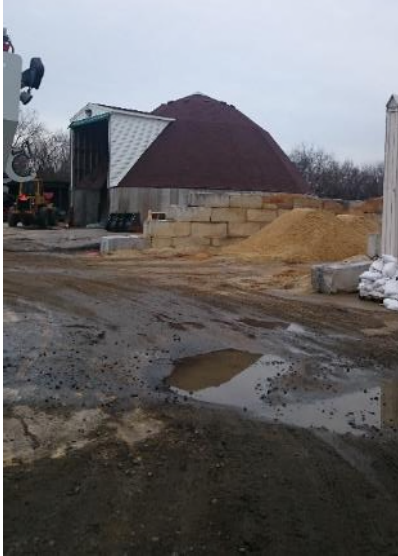
**Photograph 49. Public Works Facility: Covered Salt Storage Building G and Equipment/Materials Storage Building H (Facility map) in the background, with sand pit in foreground.**

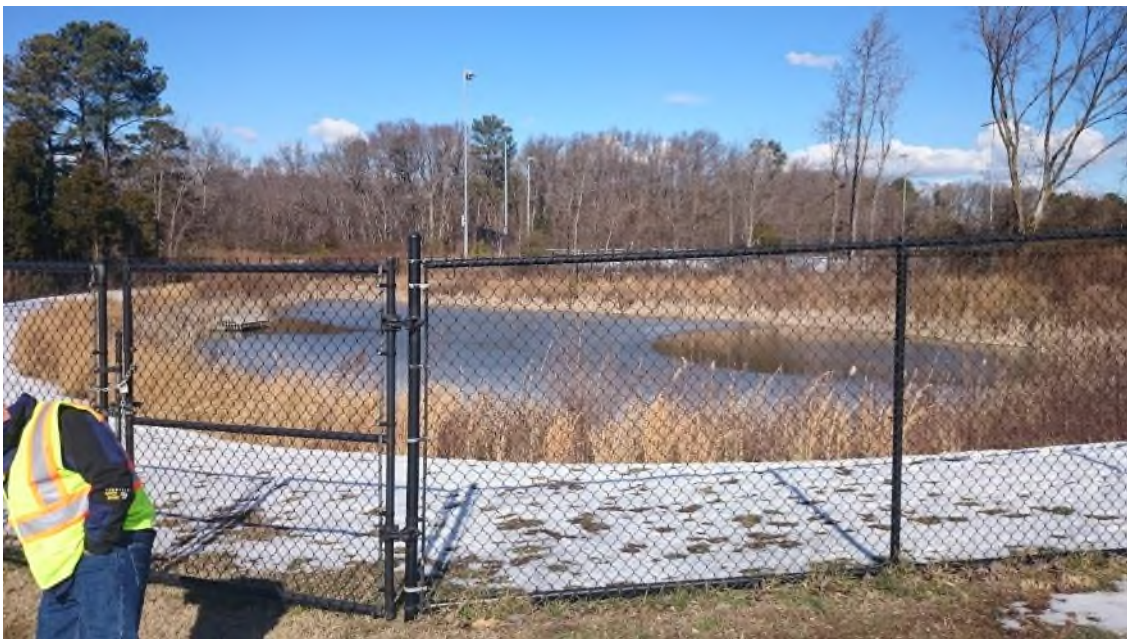
**Photograph 50. Hopewell High School Stormwater Management Facility: Stormwater Retention Pond.**

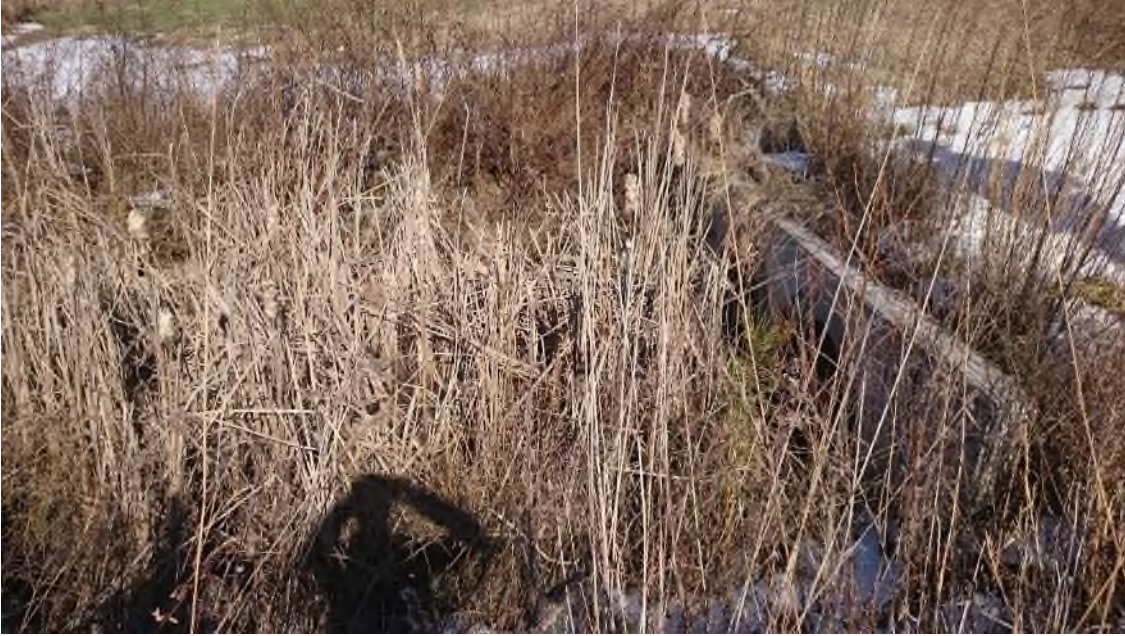
**Photograph 51. Hopewell High School Stormwater Management Facility: Pond outfall (pipe located in concrete structure at right side of photo).**

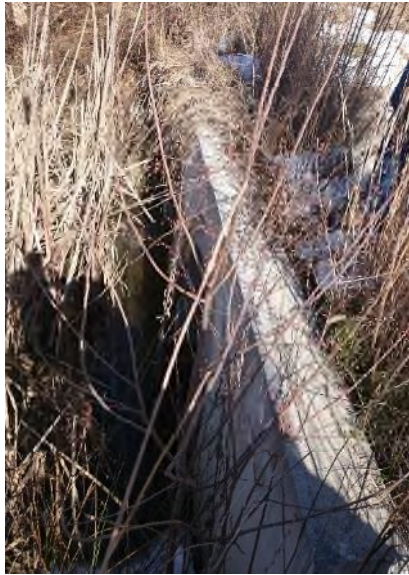
**Photograph 52. Hopewell High School Stormwater Management Facility: Alternate view of the outfall to the pond.**

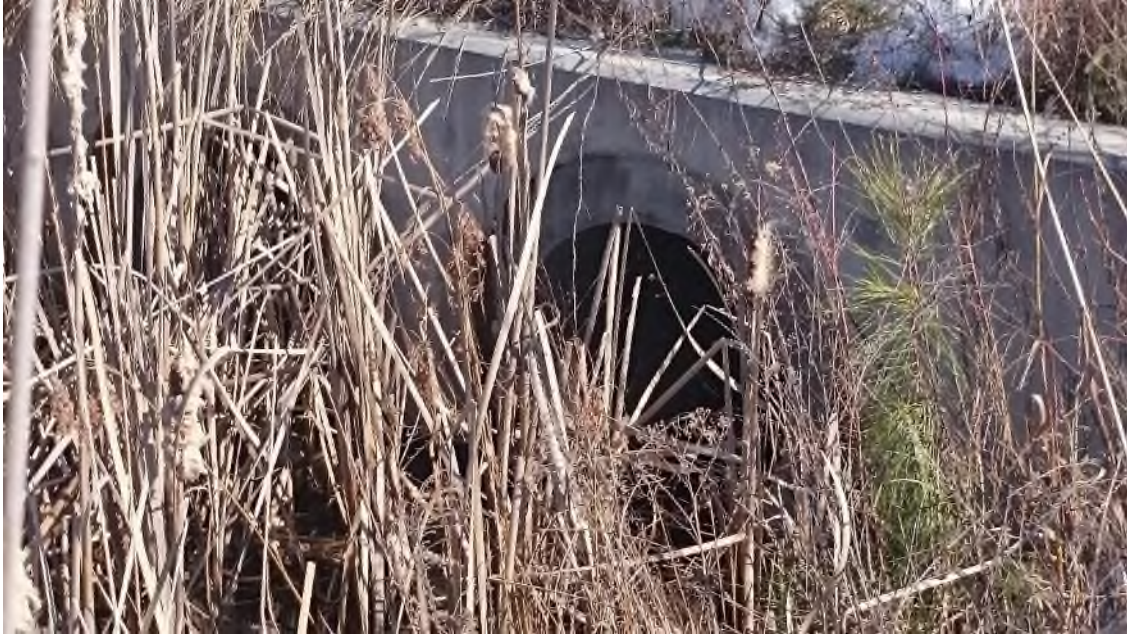
**Photograph 53. Hopewell High School Stormwater Management Facility: Alternate view of the outfall to the pond.**

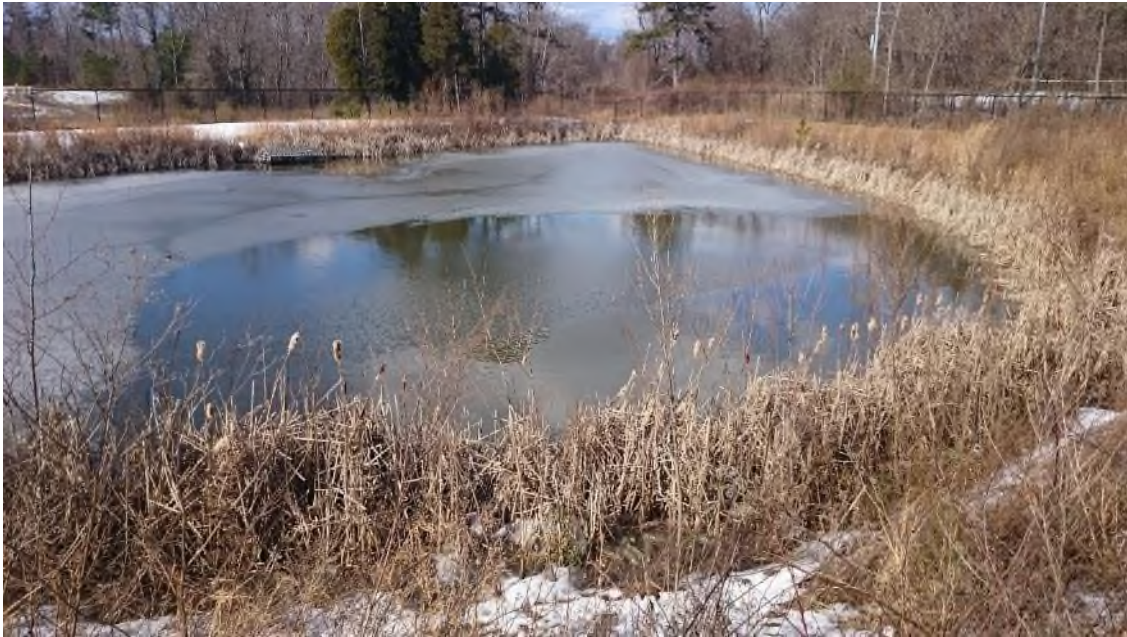
**Photograph 54. Hopewell High School Stormwater Management Facility: Inlet to pond (foreground).**

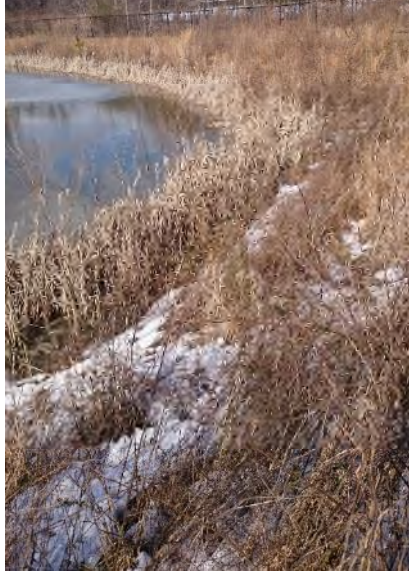
**Photograph 55. Hopewell High School Stormwater Management Facility: Inlet to pond.**
